May 22, 2016 Howard and Glasscock County Tornadoes

On May 23, 2016, meteorologists from the National Weather Service in Midland conducted a damage survey over portions of Howard and Glasscock counties for damage caused by severe thunderstorms during the evening hours on Sunday, May 22.

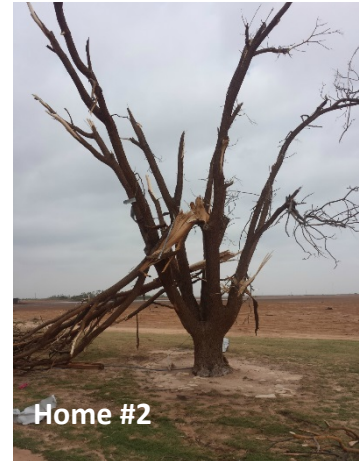
The damage assessment team looked at several different indicators to determine tornado intensity. At Home #2, which likely was the closest and strongest structure to the

tornado during the most intense portion of the tornado's life cycle, the entire roof was destroyed and exterior walls on this well-constructed residence were partially collapsed. This damage indicator suggests an EF3 intensity with wind speeds estimated at 140-160 mph. In the adjacent field east of Home #2, a 640 type pump jack was blown over. While not a formal damage indicator, similar type occurrences in past history would suggest that winds associated with EF3 tornadoes could cause pump jacks of this size to topple. The assessment team also looked at tree damage at Home #2. Both softwood and hardwood trees were viewed on the property. Damage to these large trees was indicative of high end EF2 to low end EF3 damage.
